Restoration Preparations

eams of experts have been gathered to create plans for an incredible undertaking—restoring the interior of The Basilica of Saint Mary. These many talented people have traveled, some from across the country, to start this work on our sacred Basilica. They completed a test mock-up section in early September, that will help us to prepare and plan for the larger restoration, currently planned to begin in spring of 2025.

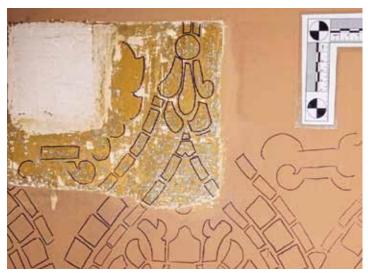
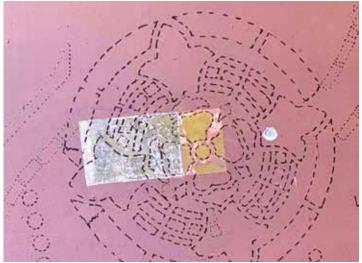
Historic stenciling revealed

The historic artwork, described by Monsignor Reardon, was recently analyzed by EverGreene's conservators. Traces of original artwork were revealed through test openings created in over-painted areas and with bright or raking lighting. Where accessible, the historic color palette and visual evidence of stenciling has been documented. Current trials will help determine conservation feasibility and will also provide an opportunity to consider the impact of lighting and cleaning on overall appearance and aesthetics.

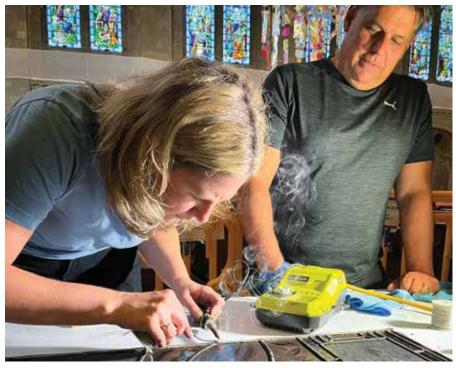
Brianne Van Vorst, Principal and Conservator of Liberty Stained Glass Conservation, working on a window.

Properly installed and spaced support bars contribute to the integrity and long-term durability of the window. It is hard to assess the strength of lead or its remaining lifespan while a window is in situ (in place). The intent of the trial is to assess the condition of the lead strips, called "cames," that hold the glass together, and feasibility of future repair.
